SUBJECT: Bayview Landfill Site--Concerns  
of West Burlington Citizens' Group

Re: Bayview Landfill Site

The purpose of this letter is to draw your attention to the deterioration of the cover of the above site, formerly known as the Burlington landfill site closed in 1970 or 1971.

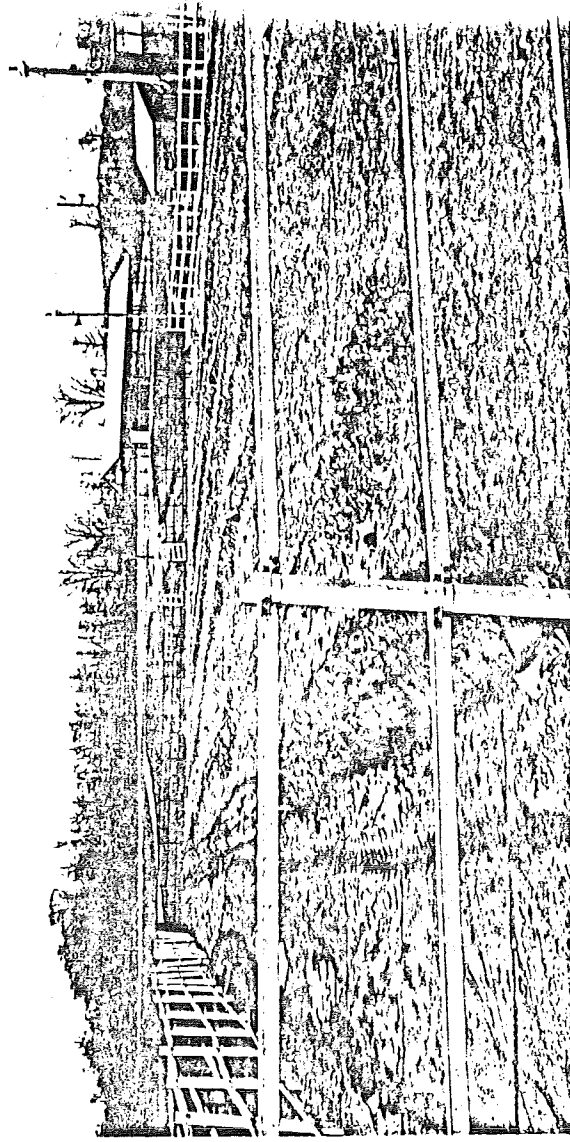
- 3) At the junction of these two roads there is a culvert under the main road - there is a great deal of erosion at this point and along the east side of the road to the south there is exposed garbage in many places.

1. South  
 10/11/1952  
 expose  
 garbage

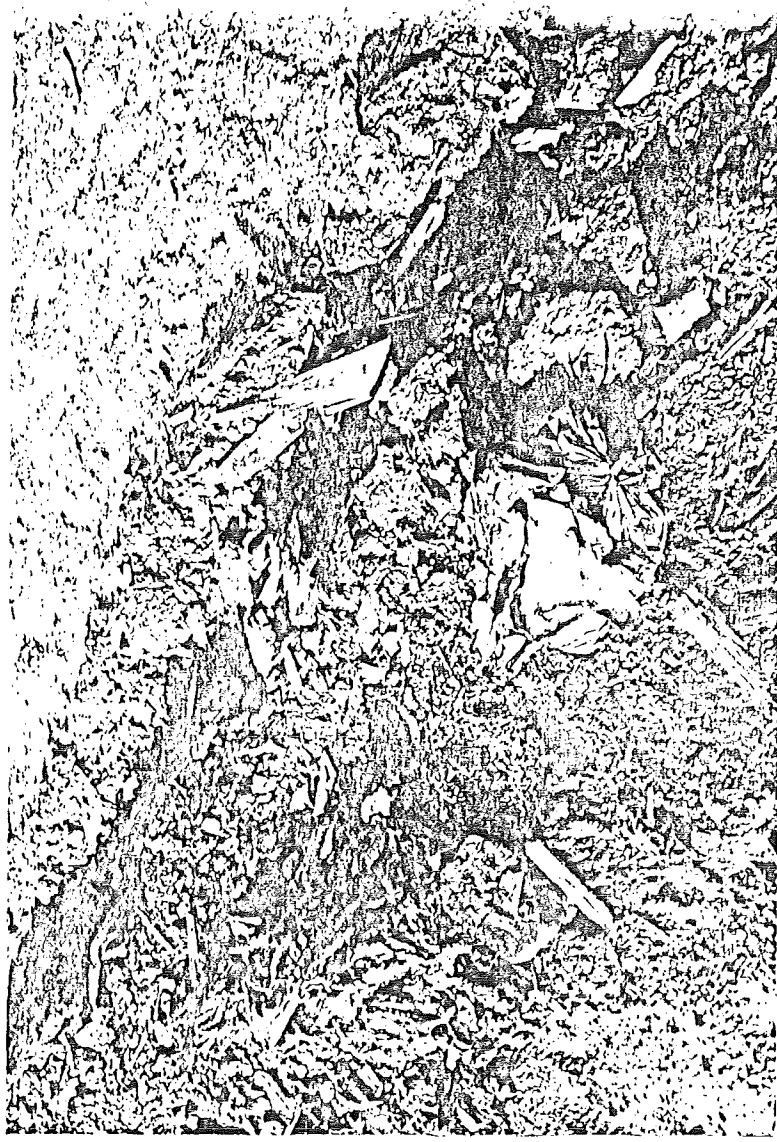
A total of 26 deep furrows gouged into them, to a depth of 18-20 inches deep were found. The result is heavy soil erosion at the west end of these two areas and in many places the furrows have been gouged right into the garbage, leaving it exposed - this is mainly in the section to the south.

2. South rink  
 Furrow detail

In the south ring garbage was disturbed when the furrowing took place. On Tuesday, December 11th, 1984 all exposed material was removed and the problem areas filled and leveled. The furrow that is shown as holding water was filled and graded to allow run-off and reduce seepage.

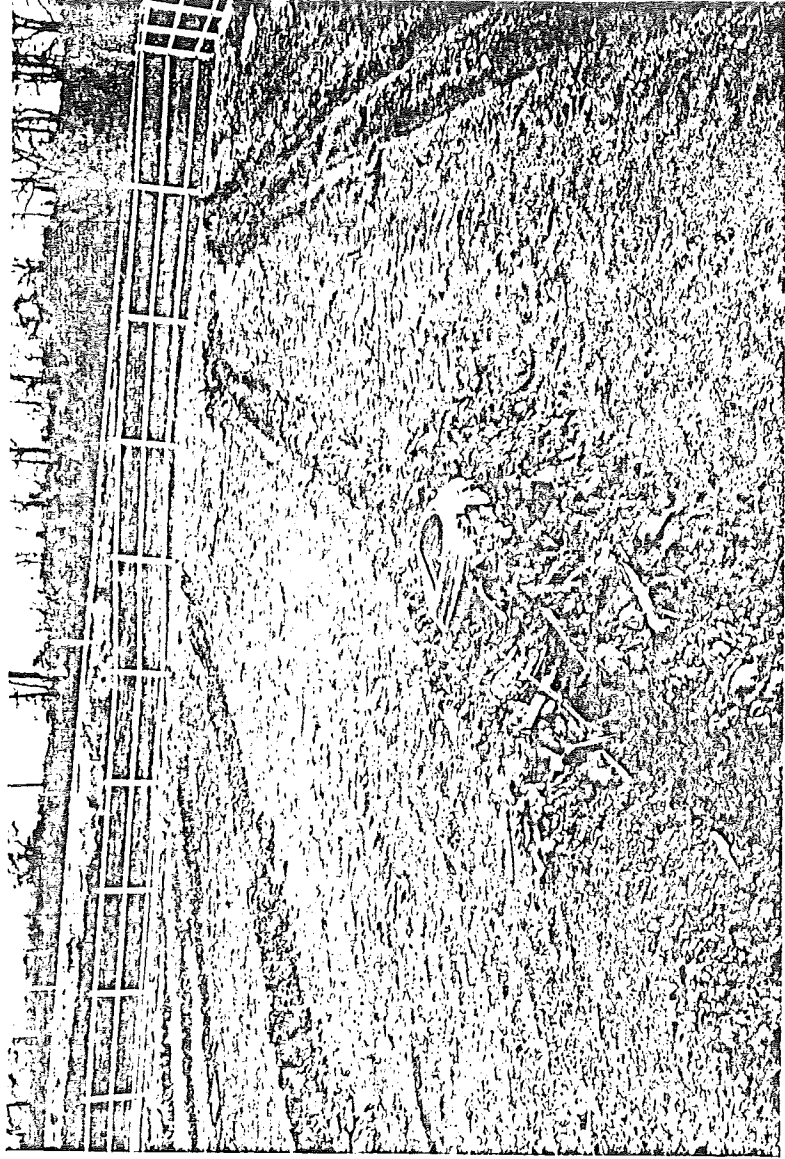
4. Garbage  
exposed  
by furrow  
(South rink)

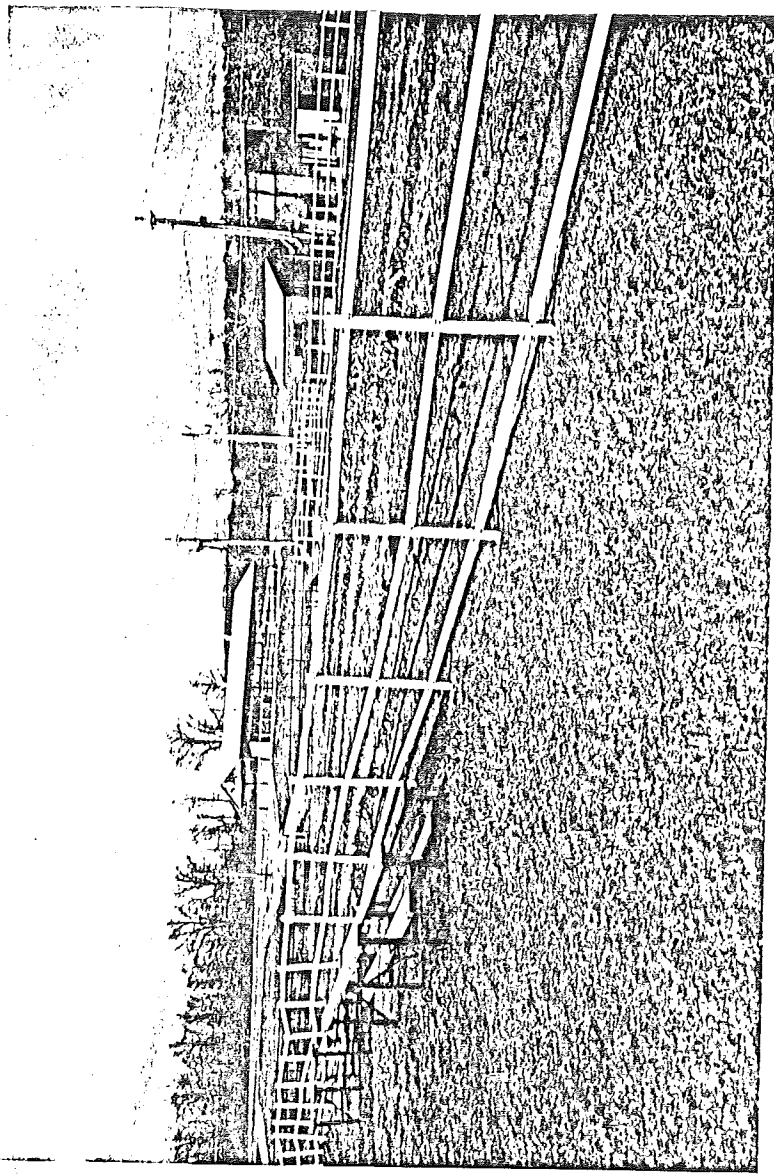
6. South rink  
grade below  
original grade  
of cap  
(stop at fence)

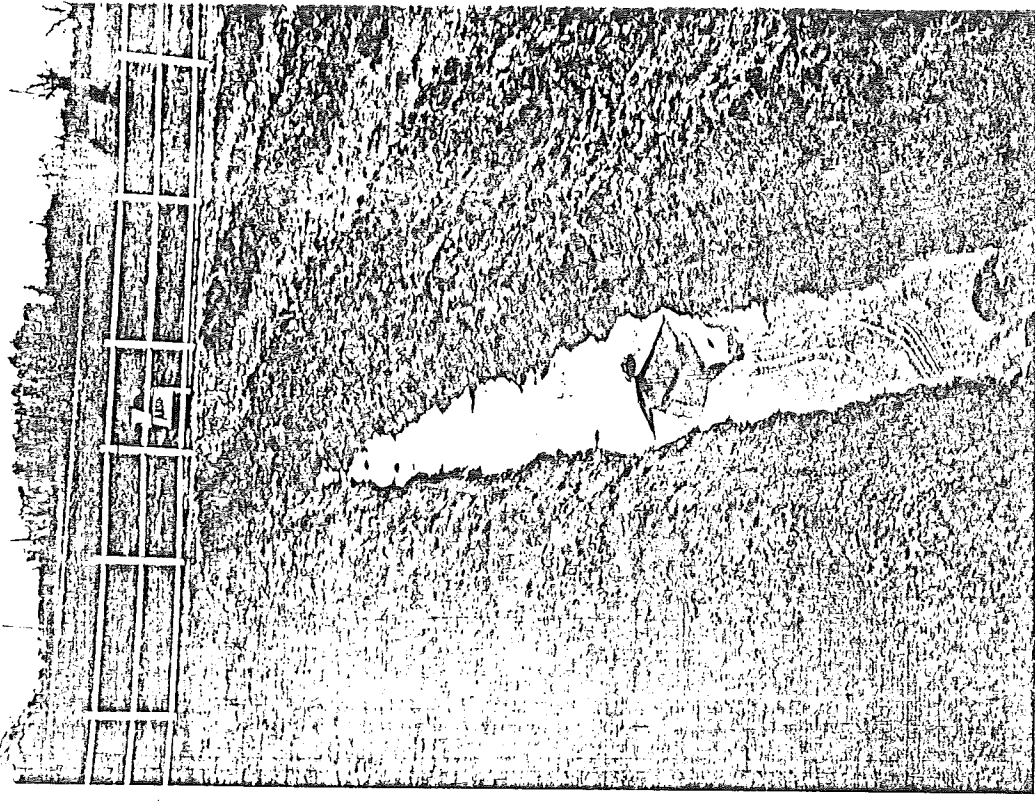
- 5) Some of the gouges had ice in them and when this was broken, there was an empty space of about 10 inches deep with no water - this would indicate that the water had seeped down into the garbage.
- 6) We are concerned because of the excessive amount of erosion on this site which would allow large amounts of surface and runoff water to penetrate into the landfill site - while this site was an operating garbage dump, it was not backfilled daily, consequently this could add greatly to the leachate problem.
- 7) Another concern is that of leachate getting into the Indian Creek system.

8. North rink  
water infiltration  
shown by water level  
below night's ice cover  
(Time approx. 10<sup>30</sup>-11<sup>00</sup> am)

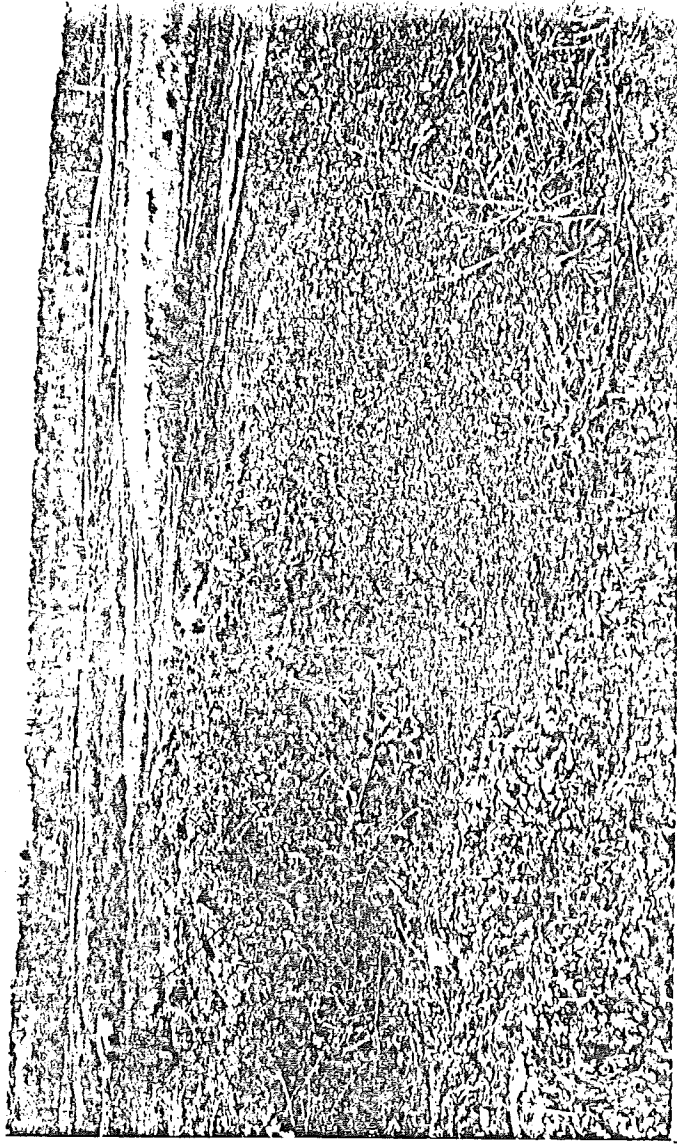
- (2) The refuse dumped at the south west corner of the park is the City's compost pile where we recycle organic refuse from the parks. The odd time, a member of the public sneaks a load of household refuse into this area of the park which is periodically removed by City staff to the proper landfill site.

9. South edge  
of Joyview -  
leaves & slash  
dumped there  
(facing North)

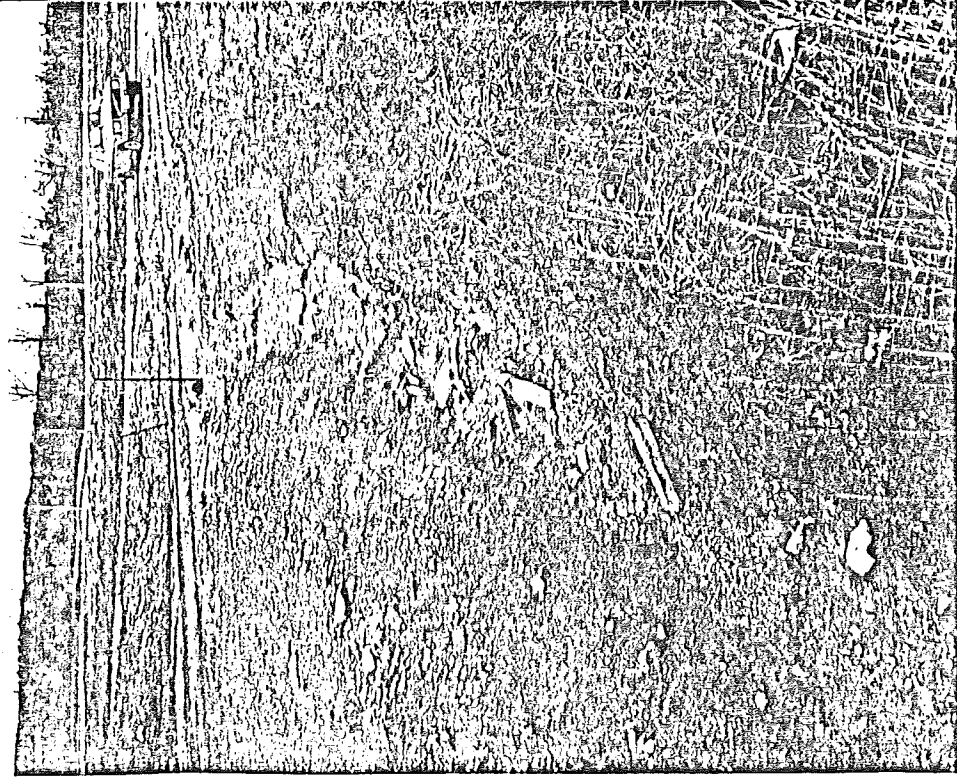
- (3) From time to time, especially following heavy rain, plastic garbage bags are exposed by erosion in several locations on the east side of the interior roadway, the side of the road on which all surface drainage water travels (south). The roadway is the only means by which drainage can take place. In the spring eroded silt and stone is graded back onto the roadway and swale. Sixty tons of limestone are then placed on these sections and the problem is solved until late fall when the problem rises once again. This erosion problem has been the subject of many discussions, but there is no way an inground drainage sytem can be constructed as household garbage is too close to the surface, and with ongoing settlements, asphalt or half metal culvert open drains would be continually breaking up.

11. Landfill cap, Y junction  
of roads: Erosion / collapse

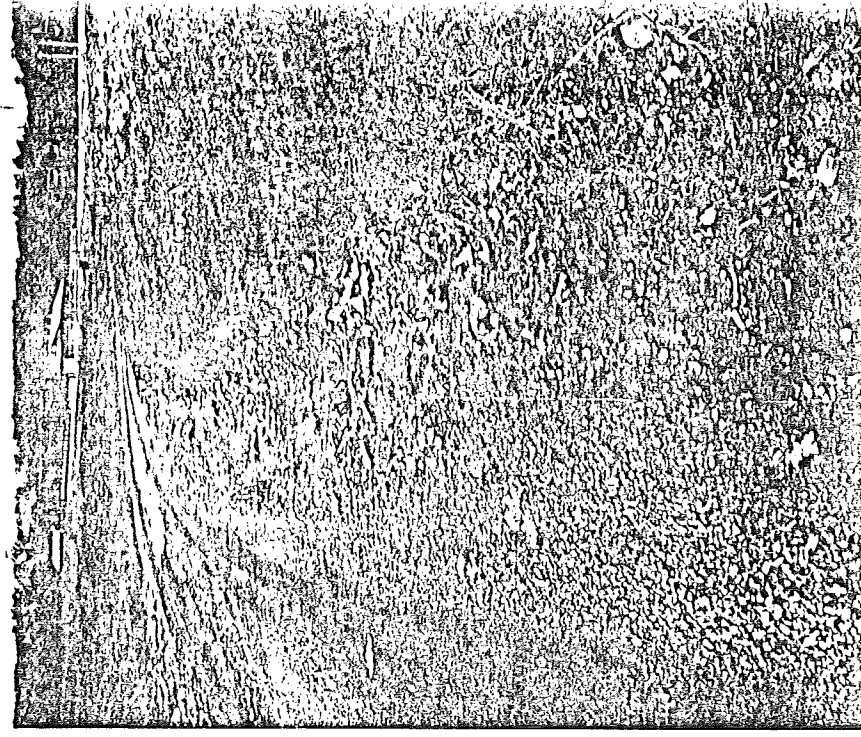
13. (As 11.), North of road junction

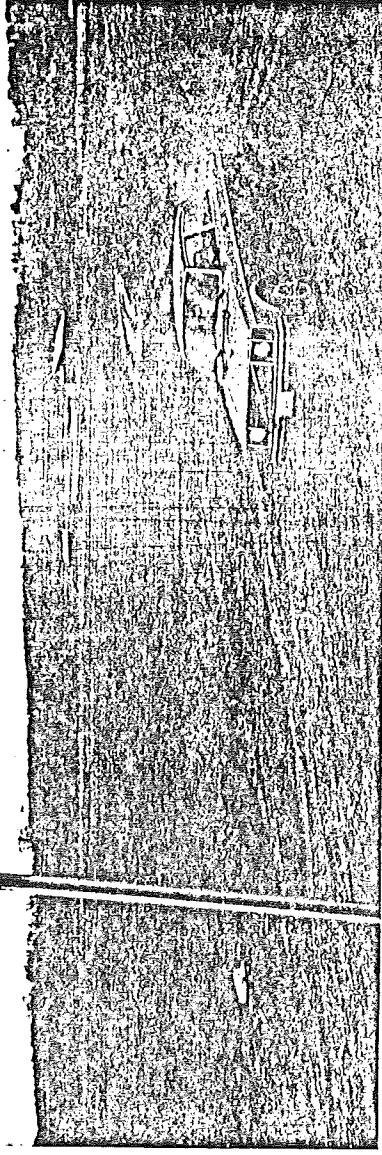
14. Forlorne "NO DUMPING" sign at Y of roads

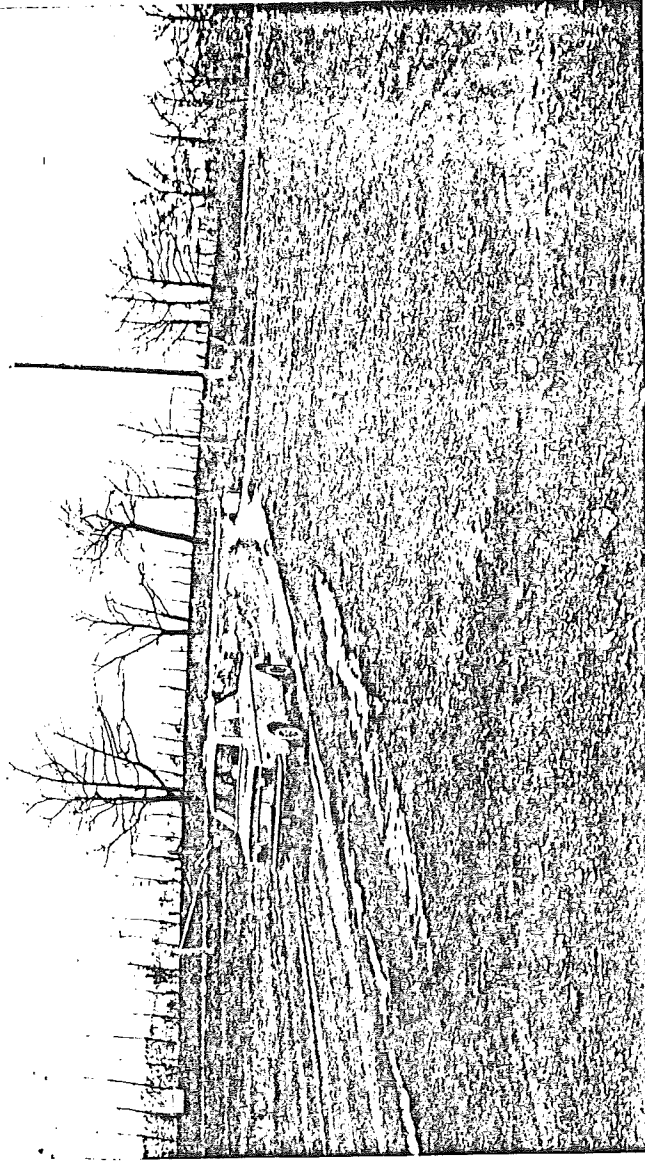
- (1) Mr. Chumley refers to park gates being removed at the south entrance and also an interior gate. These are left open to allow public access to the park. The Park's north entrance is closed during the winter months to stop through traffic as the interior road is used as a cross country ski trail.

- 1) in approaching the landfill site on King Road north of the Service Road a short distance past the Rifle Range building just at the top of the first small hill, the gate has been taken off and a road put in over the landfill site from east to northwest to allow parking for the Quarter Horse Club; in addition, halfway from the entrance off King Road to the parking area for the Quarter Horse Club, another gate has been taken off as well.

15. Road entrance (well used) is wide open  
- from King Rd., N. of rifle range (not for rinks).
