San Juan Co., N.M., Nov. 17, '84

Bayview Park, Nov. 17, '84

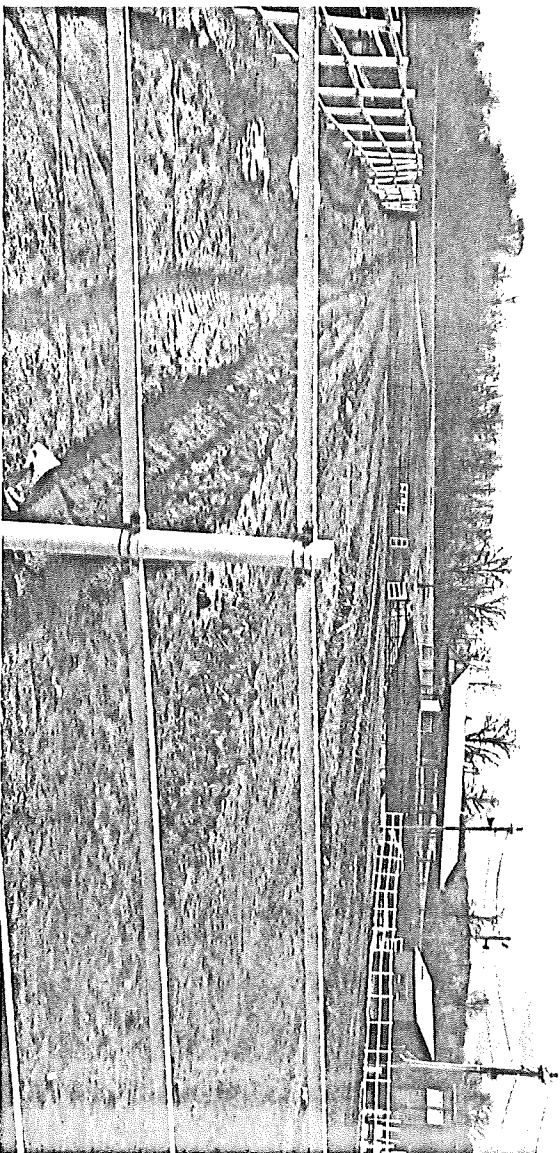
1. South side  
Furnace  
crucible  
garbage

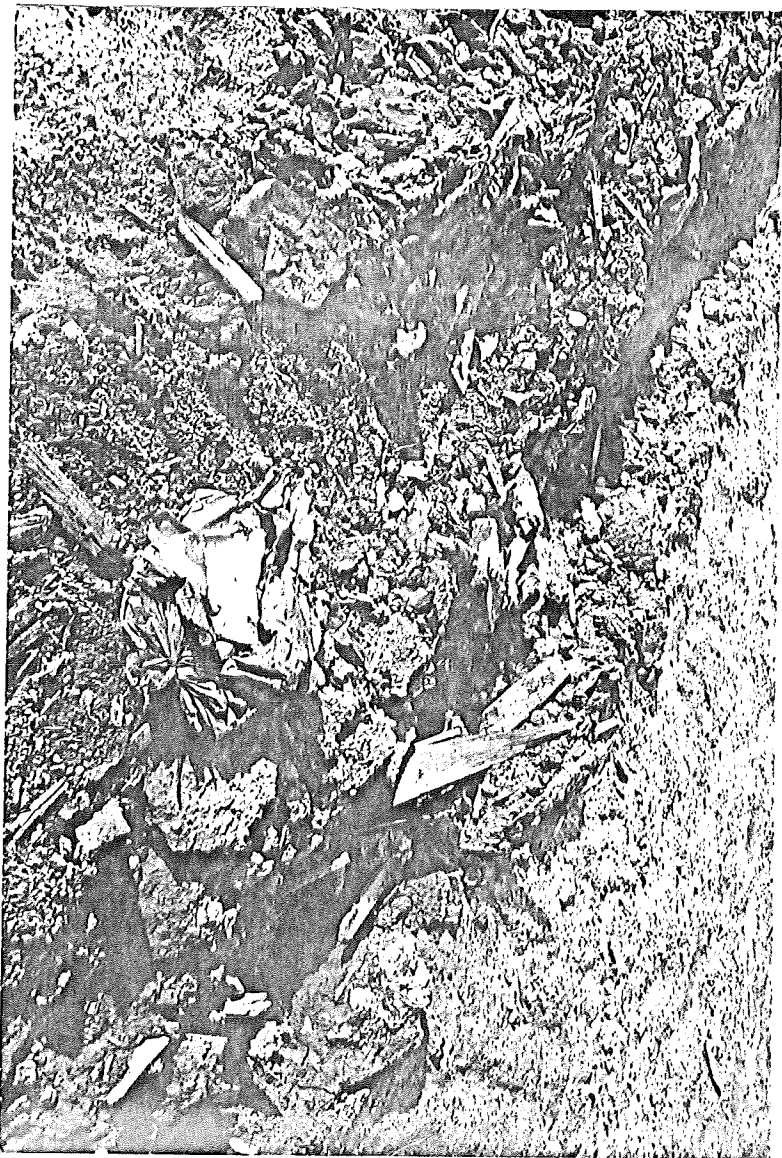
2. South side  
Furnace detail

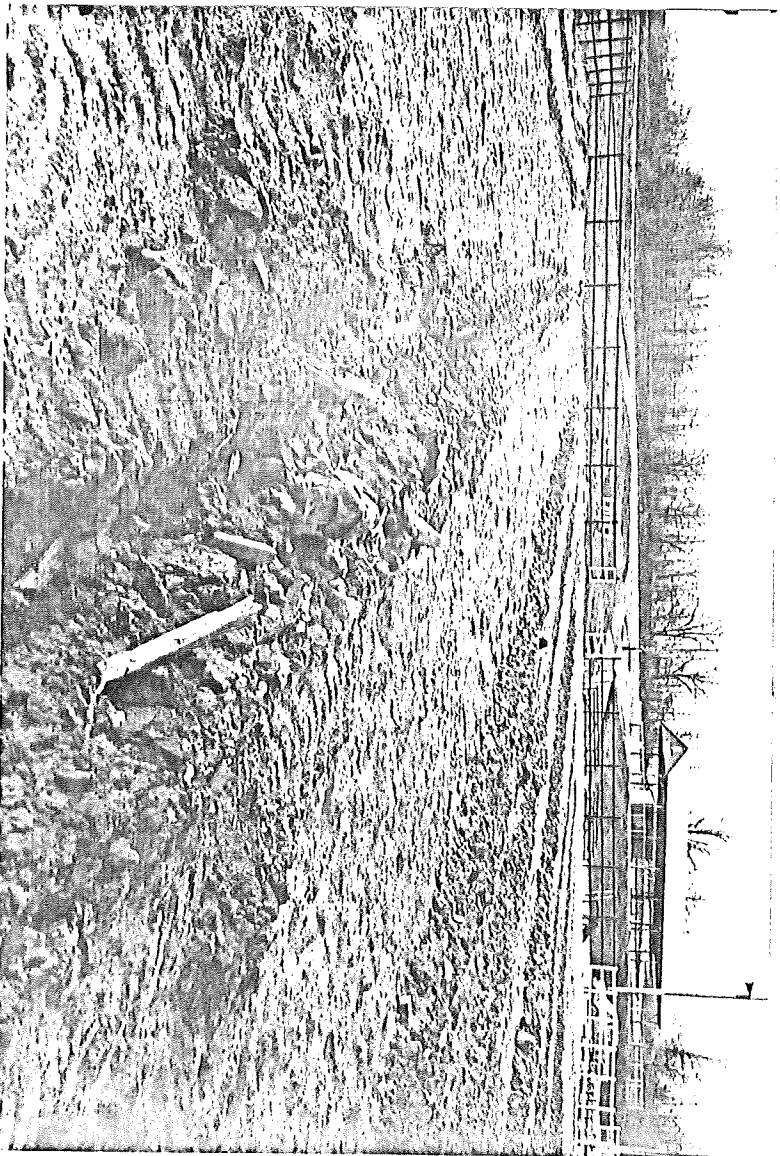
3. South side  
Another detail  
incl. location

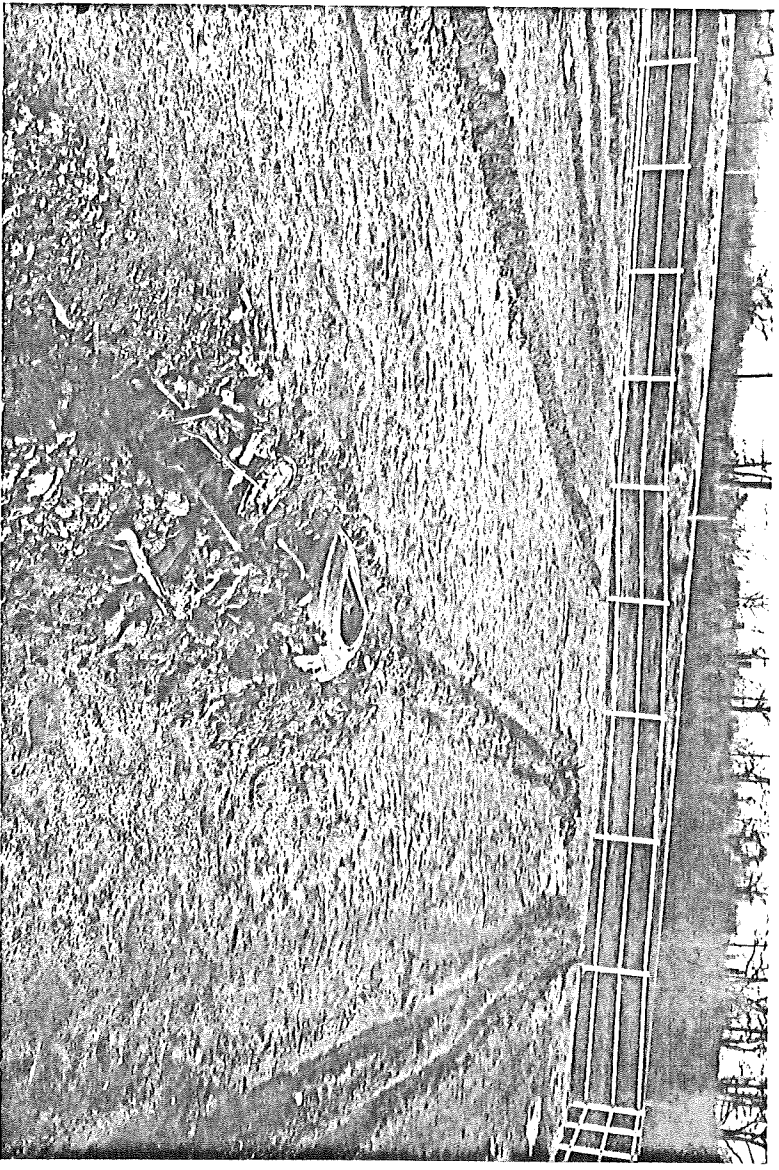
4. Garbage  
exposed  
by furrow  
(South rink)

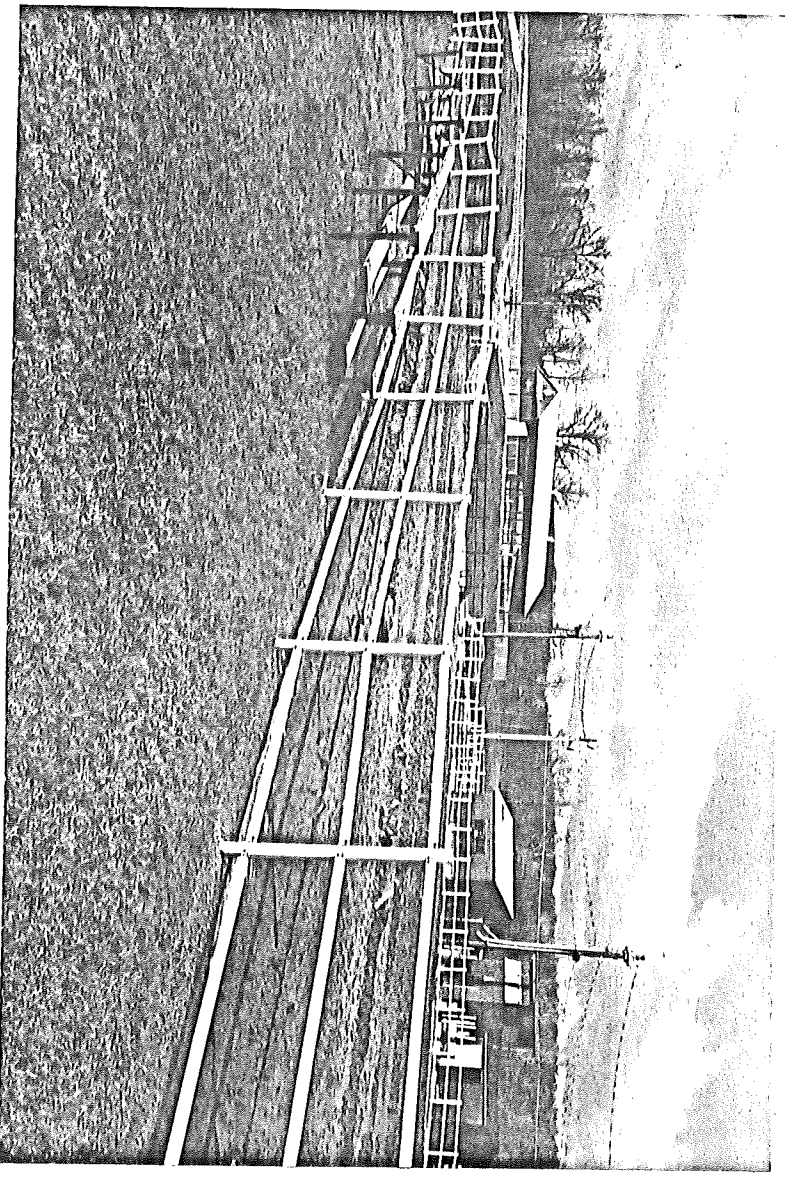
6. South rink  
grade below  
original grade  
of cap  
(stop at fence)

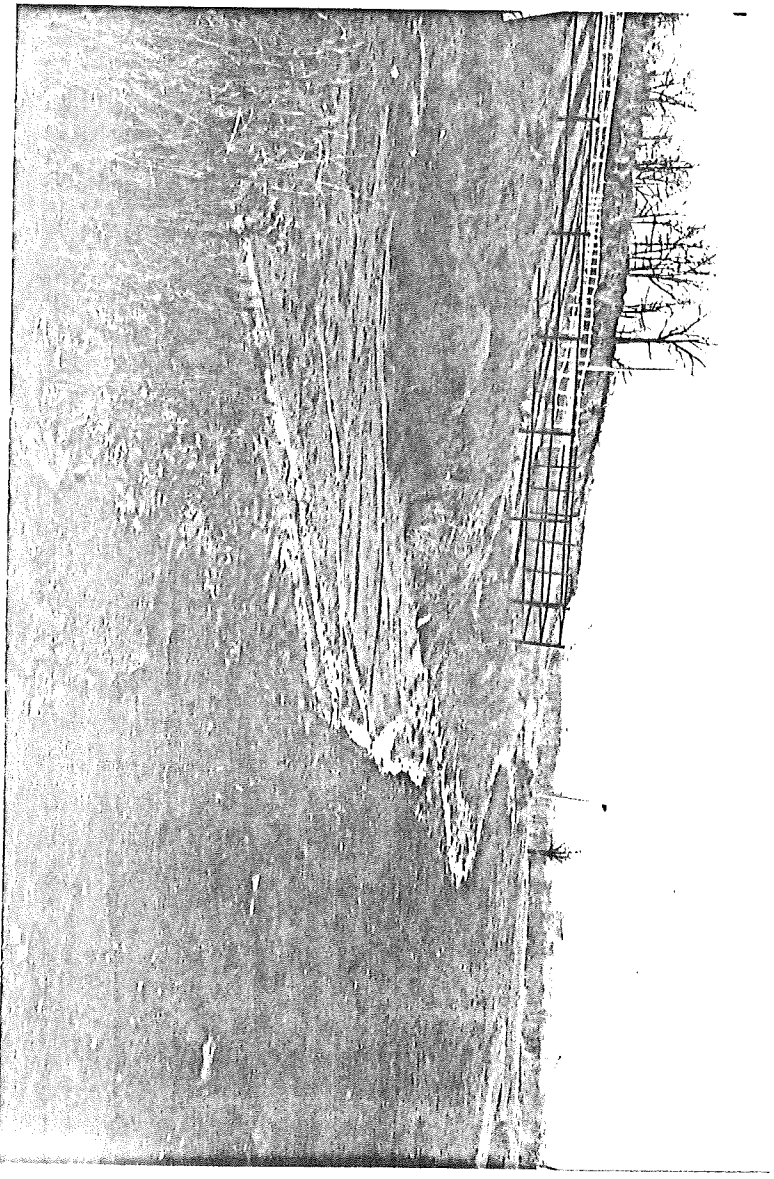
7. Erosion  
at SW corner  
of South rink

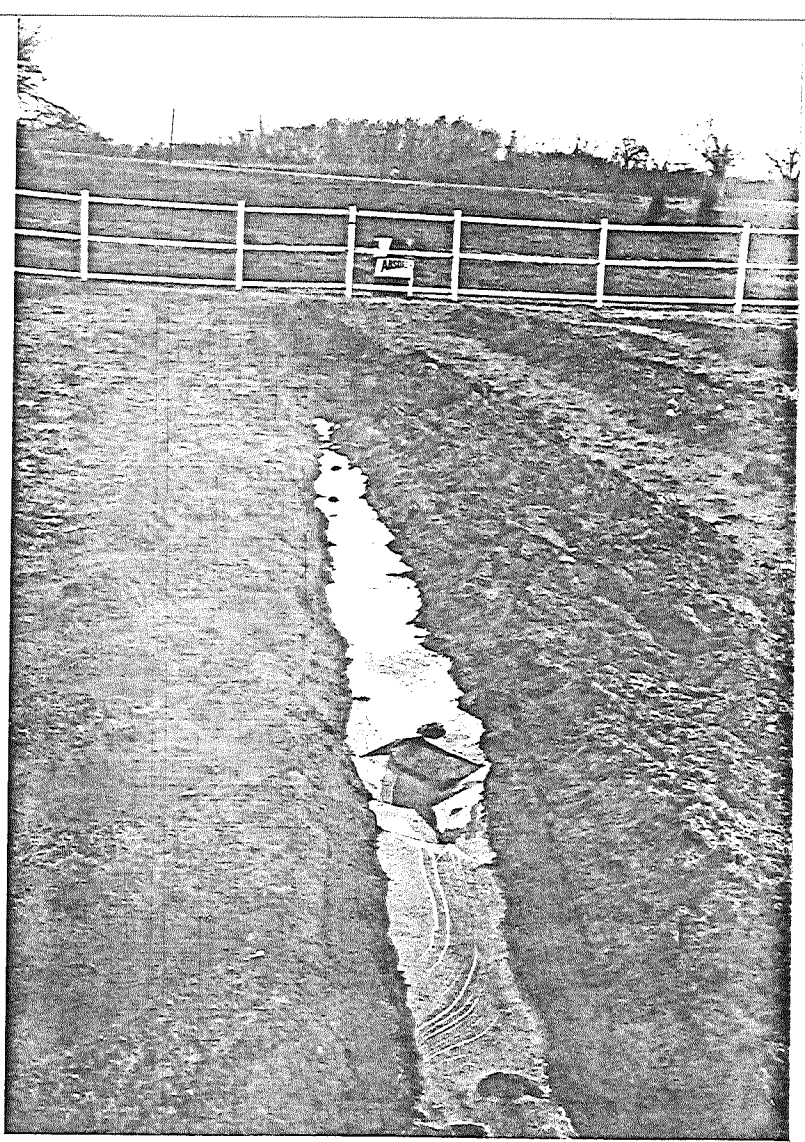
8. North riuk  
water infiltration  
shown by water level  
below night's ice cover  
(Time approx. 10<sup>30</sup>-11<sup>00</sup> am)

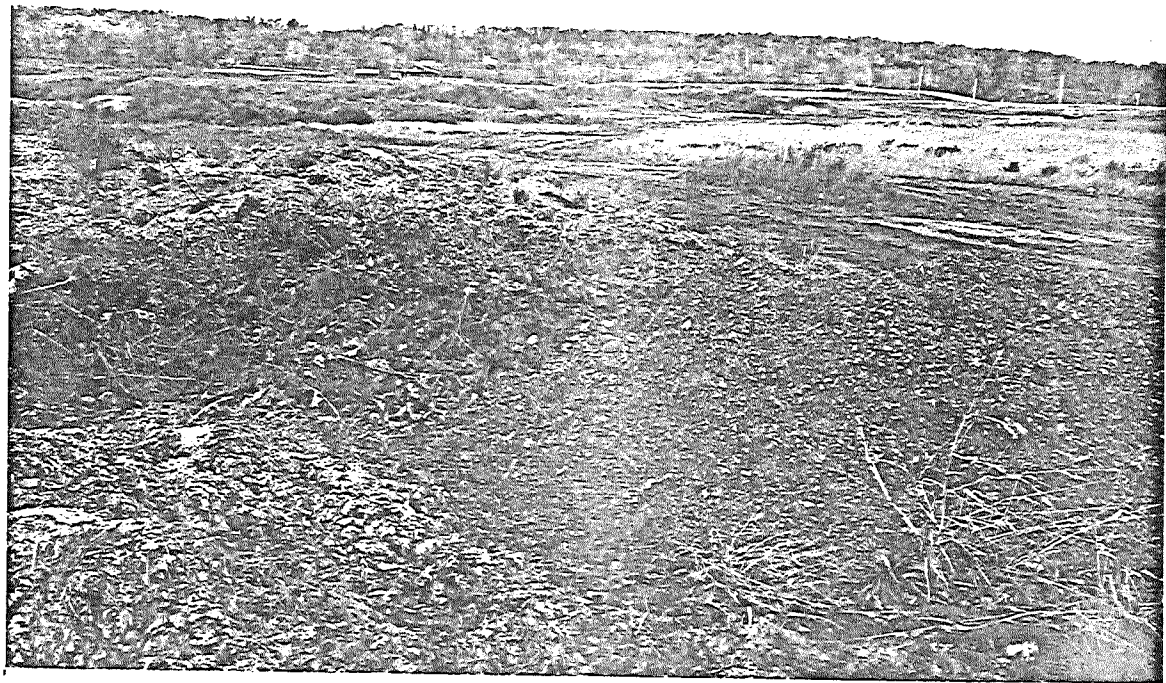
9. South edge  
of Bayview -  
leaves & slash  
dumped there  
(facing North)

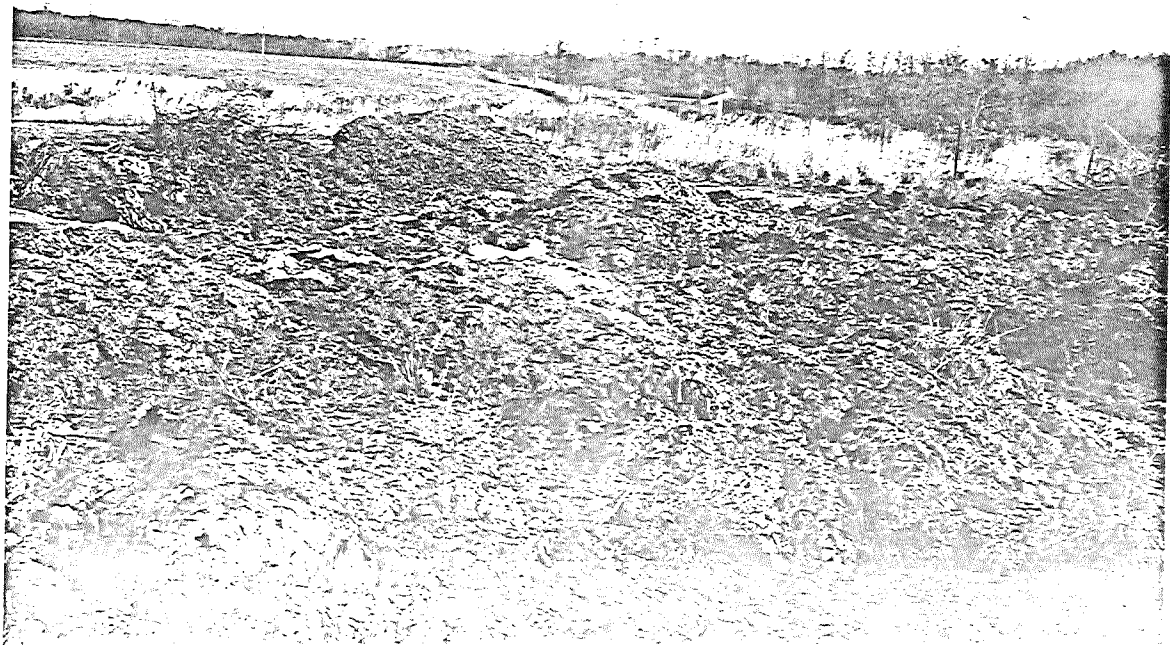
10. (as 9.)  
(facing East)

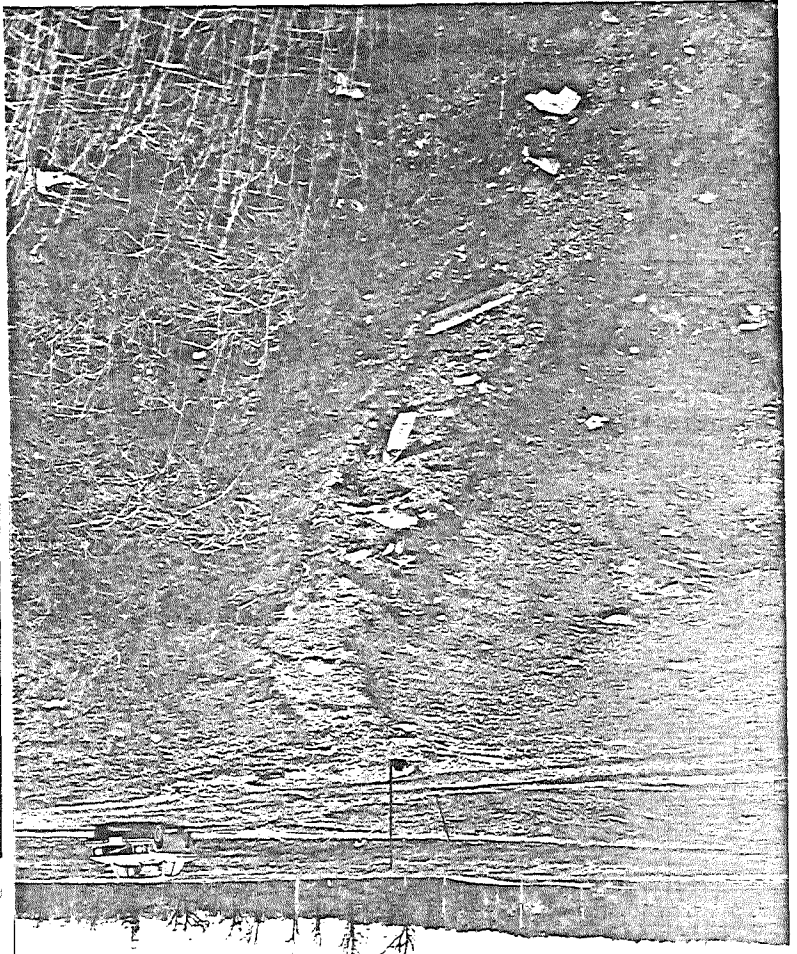
11. Landfill cap, Y junction  
of roads: Erosion/garbage

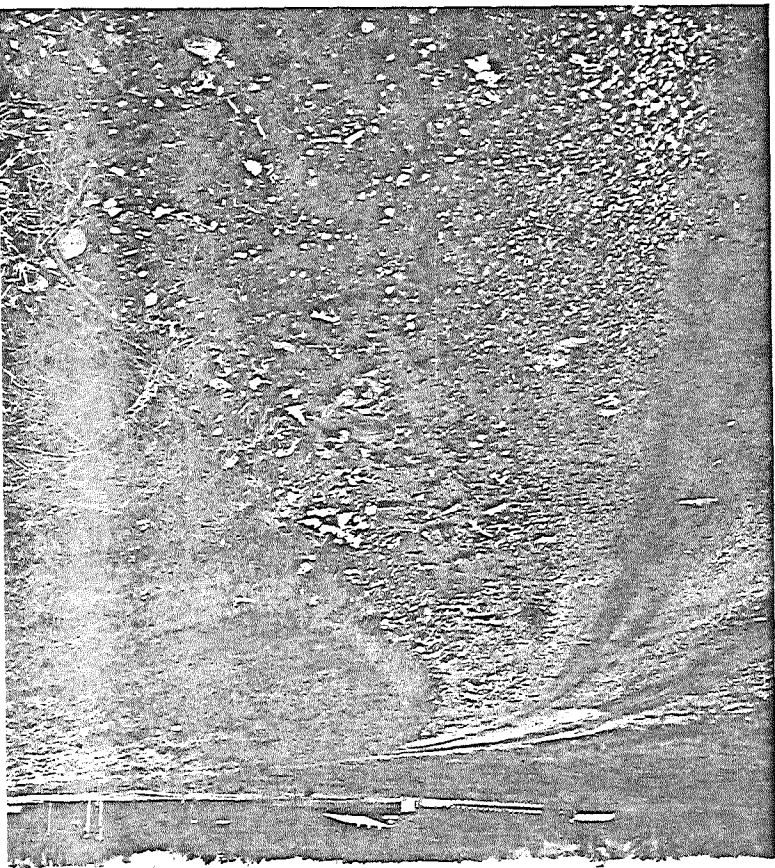
13. (As 11.), North of road junction

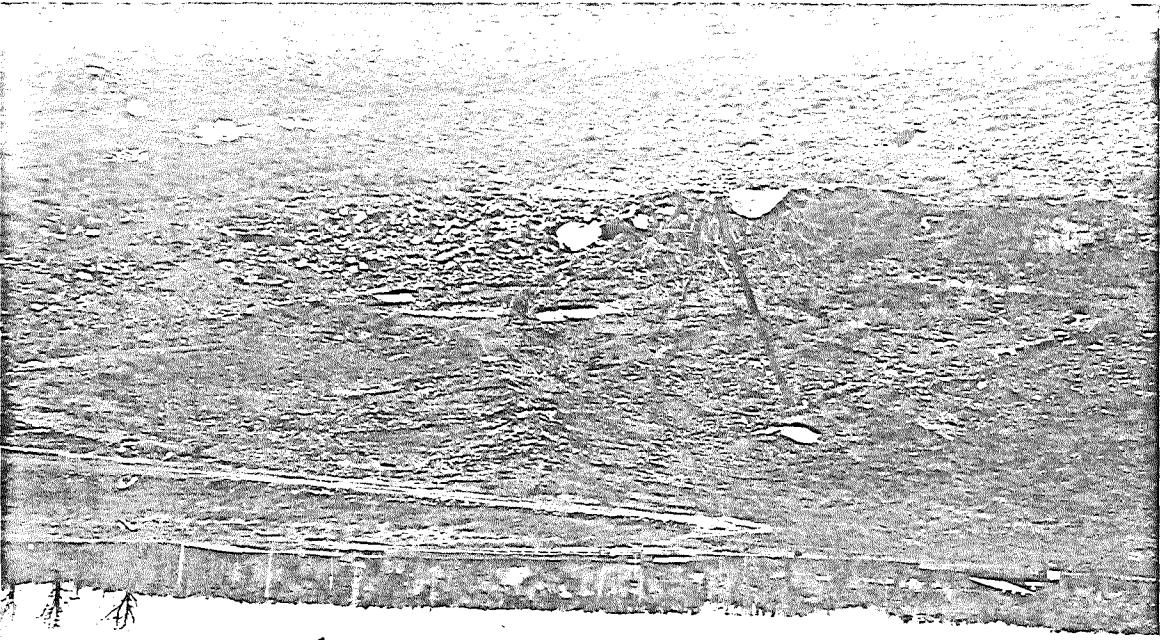
12. Erosion at Y junction of roads.  
Note stony soil (infiltration)

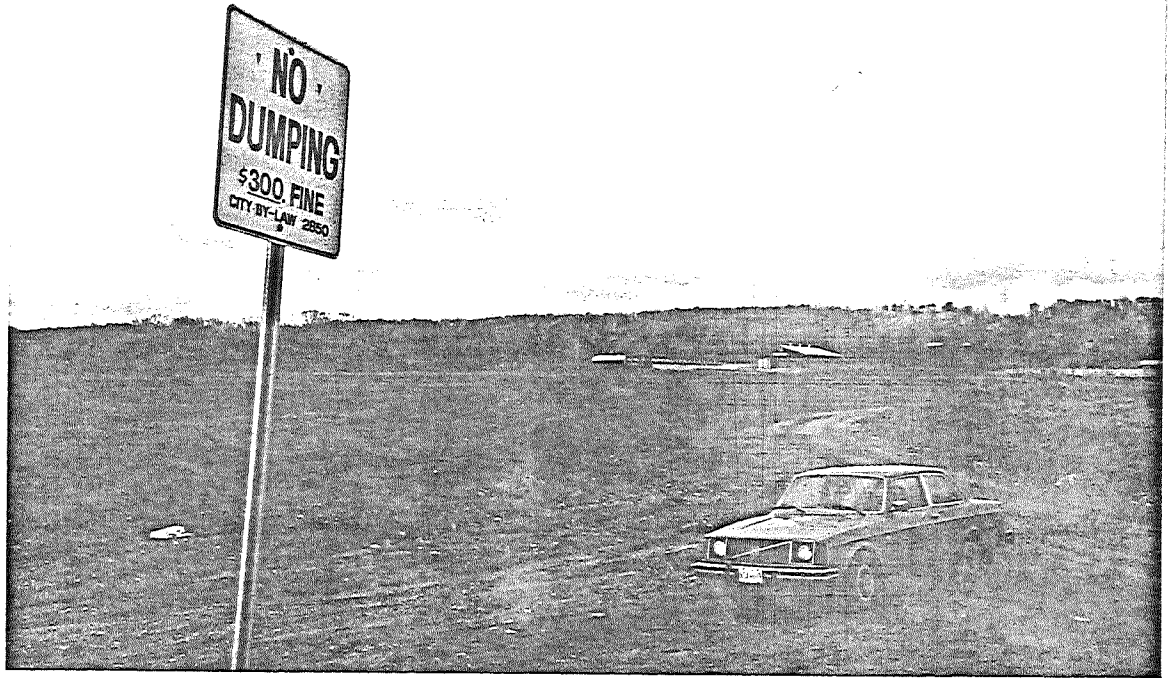
14. Forlorne "NO DUMPING" sign at Y of roads

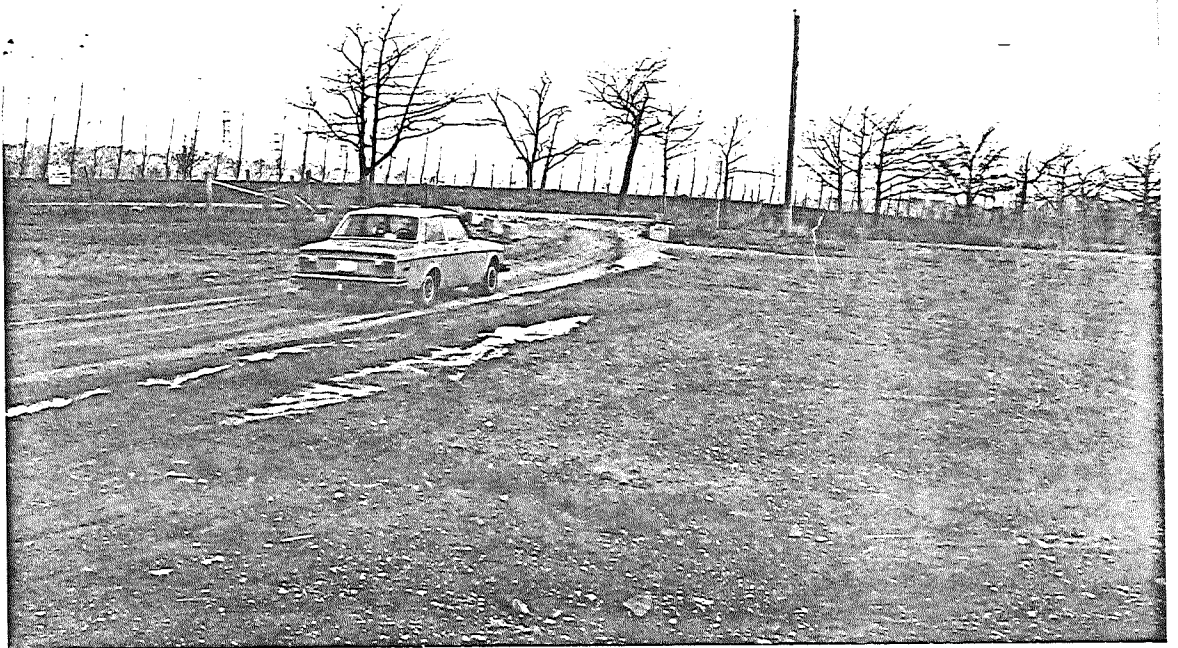
15. Road entrance (well used) is wide open  
- from King Rd., N. of rifle range (not for rinks).
