HERITAGE FEATURES ASSESSMENT  
SITES D and F

HALTON REGION LANDFILL TECHNICAL  
STUDY

SCHEDULE F

AUGUST 1986

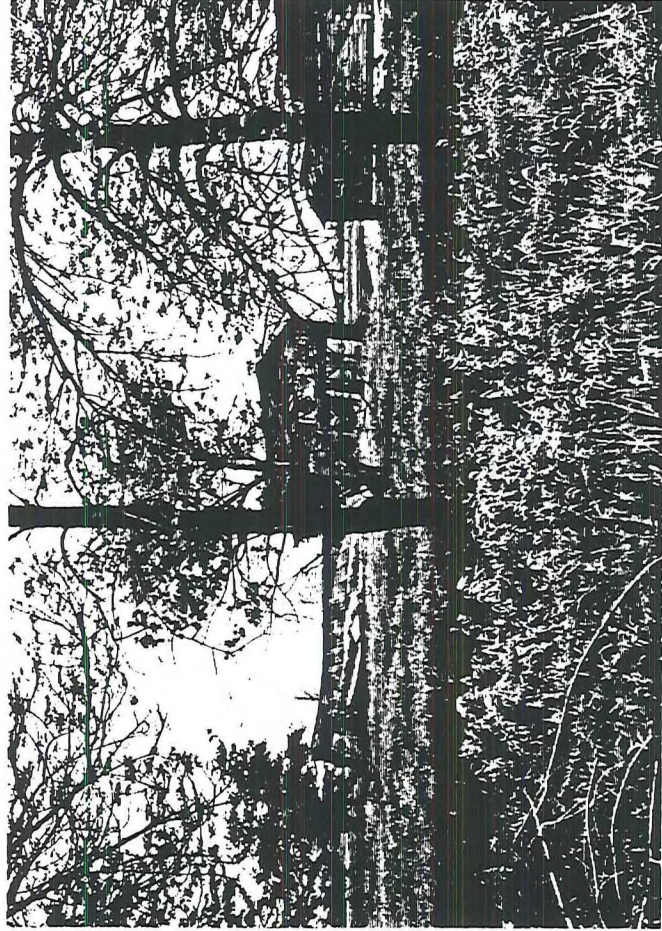
Left to right:  
Driving shed, small barn (ruins) and outbuilding

small adjacent barn are of an earlier construction (late 19th century) and are in ruins.

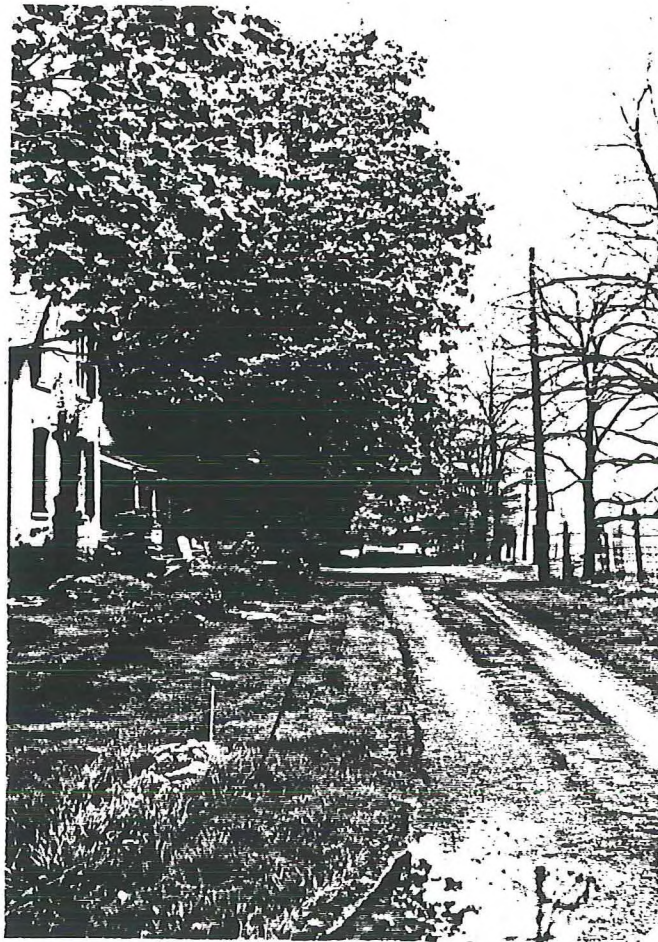
Laneway plantings - Horse Chestnut and Black Walnut

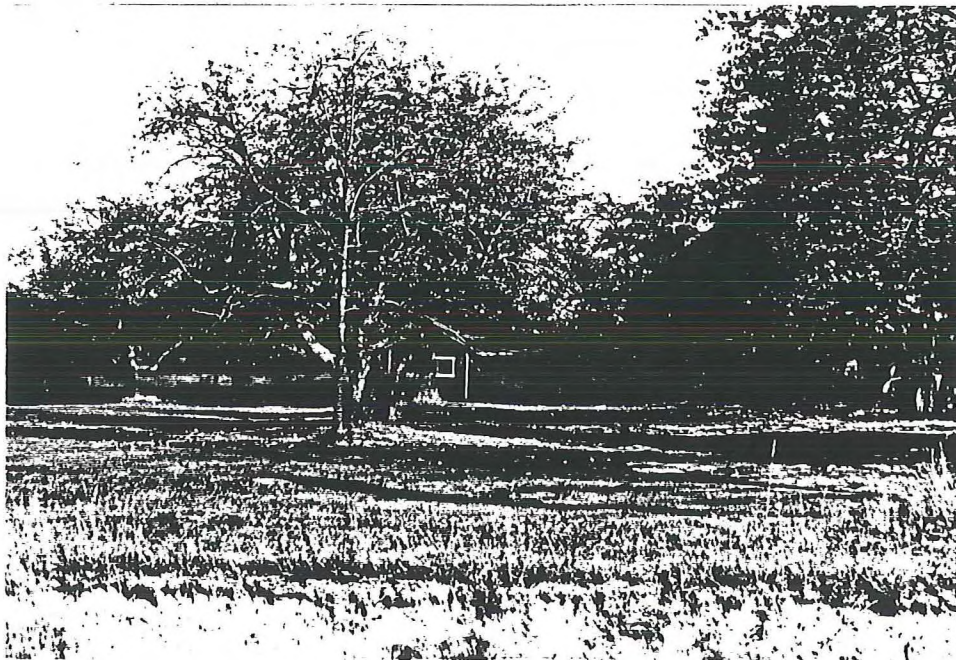
Apple orchard and one of two shelterbelt plantings

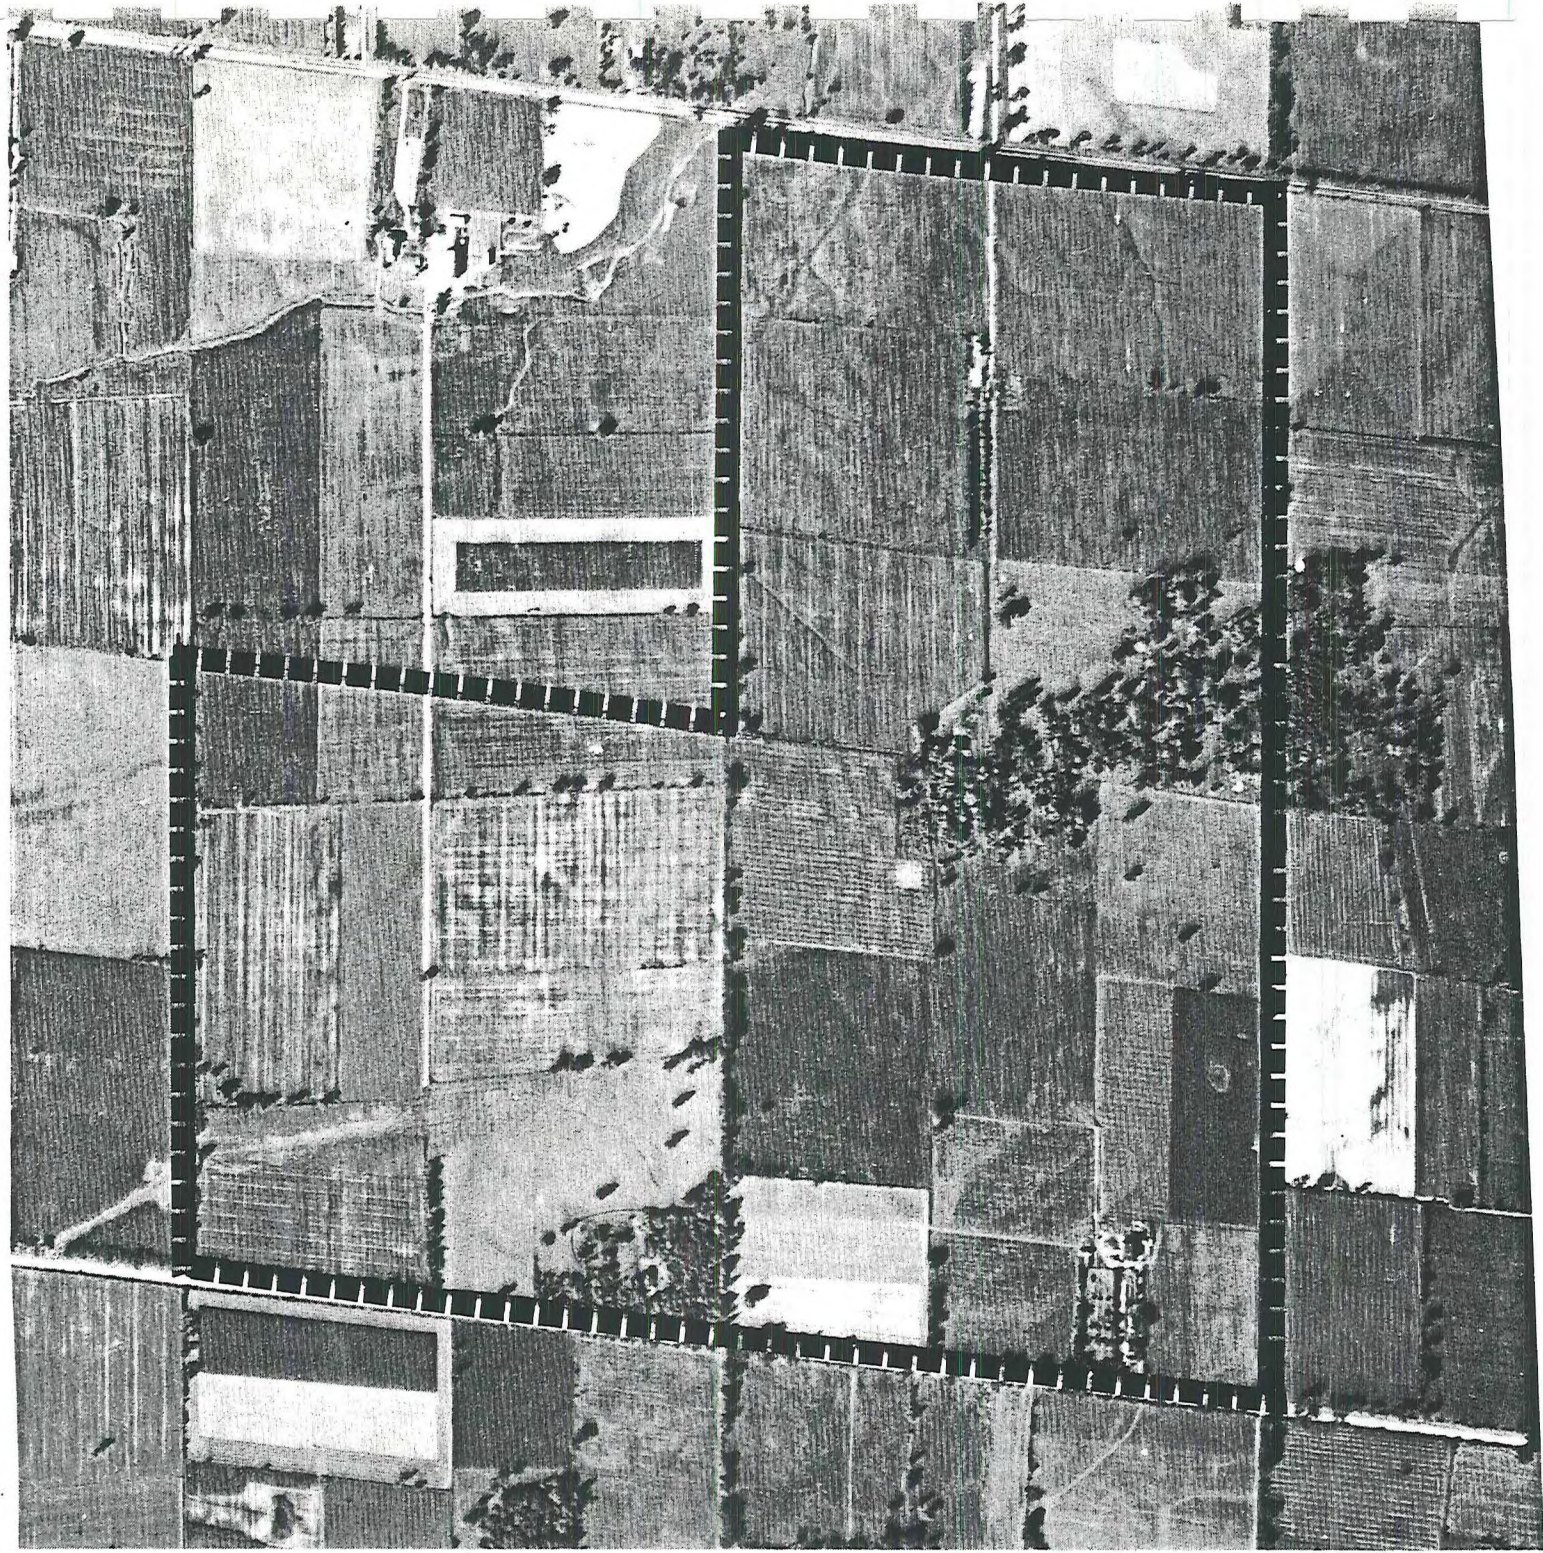
SITE D - 1953

field patterns and fence rows completely different from those which currently exist on Site D (See Appendix D, Aerial Photographs). The 1953 photographs show a pattern of small fields and hedgerows. These have all been combined into large fields and the hedgerows removed, as can be seen in the recent aerial photograph. The only remaining heritage features are the above named residence, barns, and plantings. The three heritage features are considered to be locally significant as they meet the criteria noted above. None of the features have been designated by local or provincial governments or agencies.
