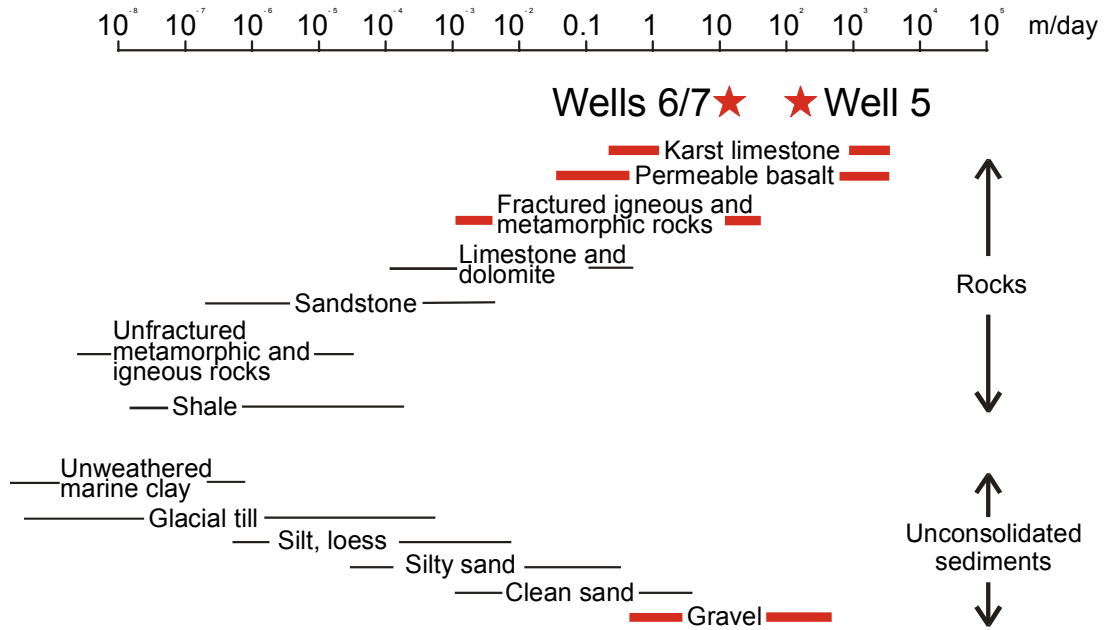
- 1) Velocity in this diagram is calculated from the hydraulic conductivity values of Freeze and Cherry (1979, p. 29, reproduced in Exhibit 261), from the hydraulic gradient at Walkerton (0.002), and from an effective porosity of 35% for unconsolidated materials, 10% for sandstone, and 0.1% for other rocks.
- 2) Aquifers considered by the US EPA to be susceptible to bacterial contamination are shown with bold bars.
- 3) Estimated velocities for Walkerton wells using the pumping test results are shown with asterisks.

Figure 1 Comparison of groundwater velocities in rocks and unconsolidated sediments

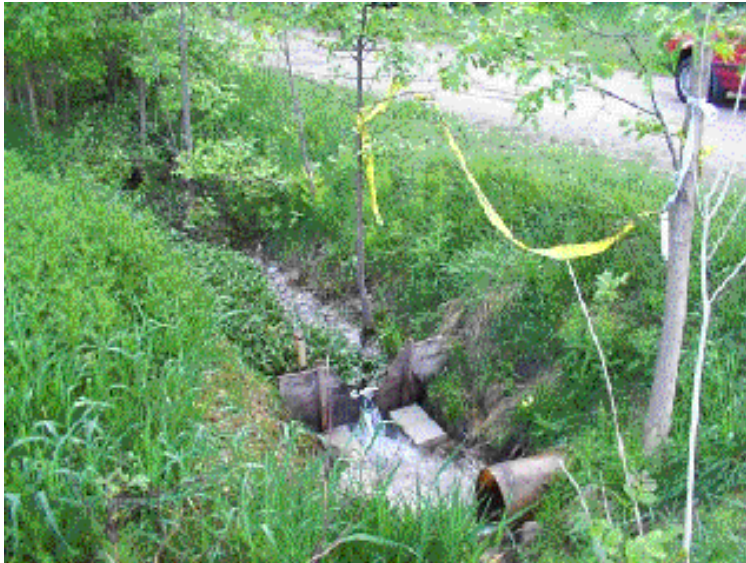
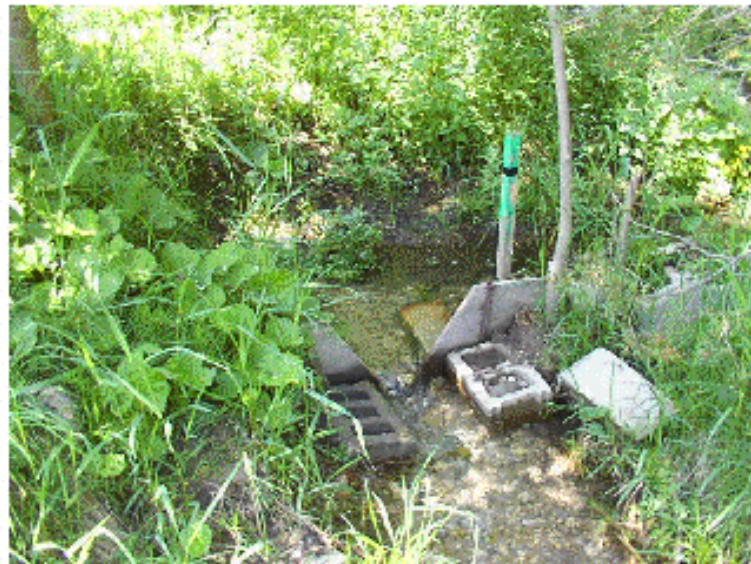
Figure 9 Drainage from the spring close to Well 5. Top: the creek on the south side of the road leading to Well 5. Bottom: the gauging structure at the point where the south creek spring emerges from the culvert and joins the north spring creek. This point is 60 m from Well 5.

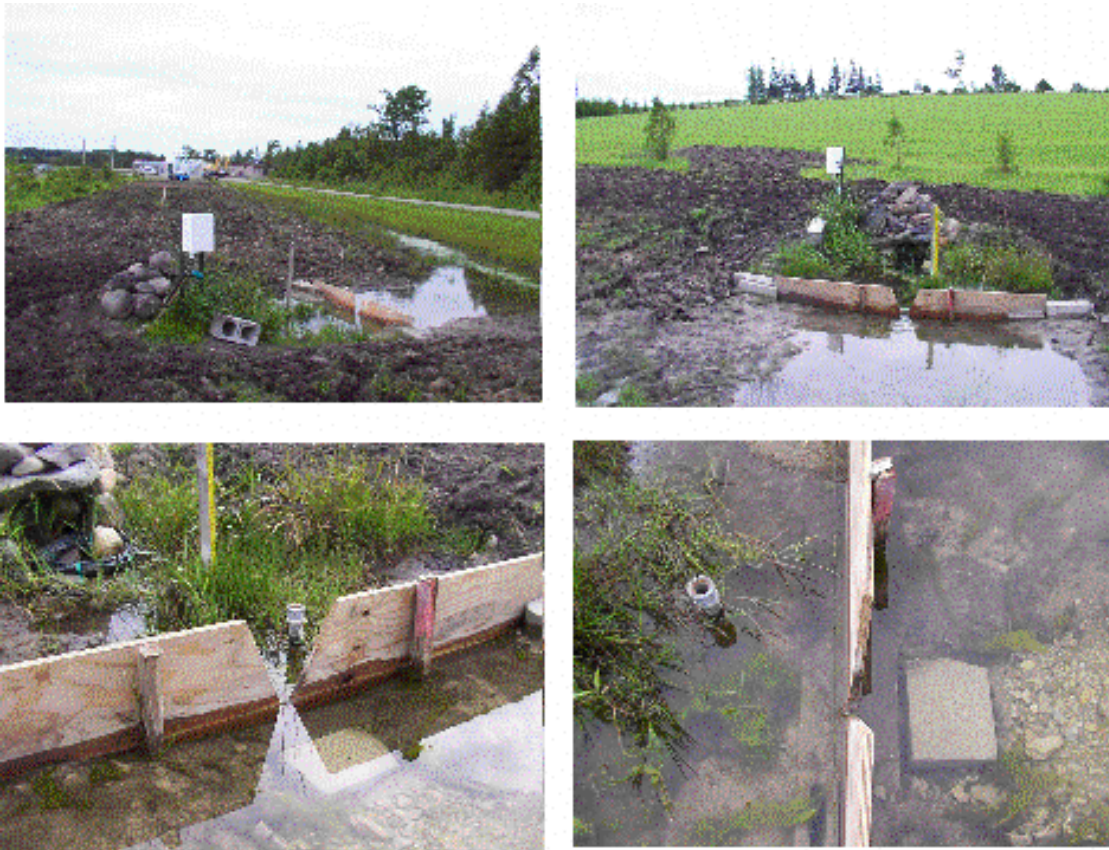
Figure 10 Four views of Spring B, midway between Wells 6 and 7, on July 3 2001

Top left 7:50 a.m. Well 7 started pumping at 5:15 a.m. The flow out of the spring is 2.4 L/s (32 gallons per minute)

Top right: 7:50 a.m. The spring emerges from a pipe about 10 m long. The actual location of the spring is at the area of bare soil in the background.

Bottom left: 4:55 p.m. Well 7 has now been pumping continuously for 11 hours and 40 minutes. The water level has now declined to the point where the spring has ceased flowing and 0.22 L/s (2.9 gallons per minute) are flowing from the surface into the aquifer. The plywood weir is acting as a dam, preventing even more inflow into the aquifer.

Bottom right: 4:55 p.m. A vertical view of the water flowing over the weir and into the aquifer.
